MARINE INVESTIGATION REPORT  
M01N0020

FLOODING AND SINKING

SHRIMP FACTORY FREEZER TRAWLER *FAME*  
120 NAUTICAL MILES NORTHEAST OF  
BELLE ISLE, NEWFOUNDLAND AND LABRADOR  
19 APRIL 2001

Report Number M01N0020

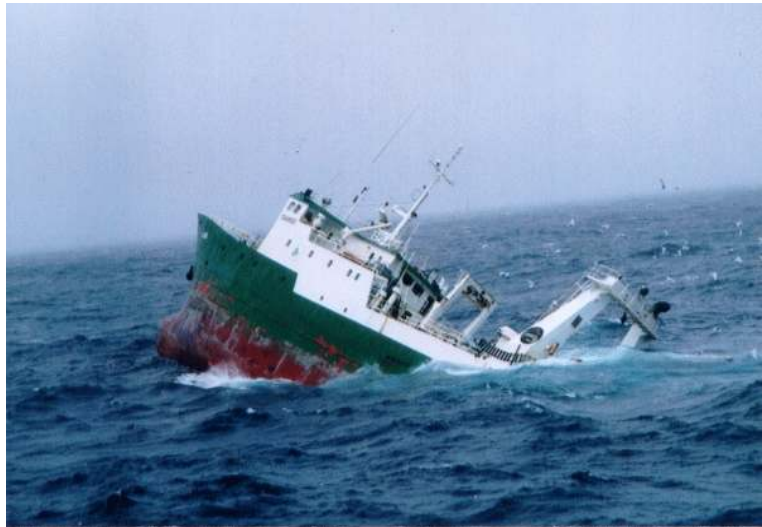
Photograph 2. F.V. *Fame*, pronounced list.

As the trim by the stern increased, the shipped water downflooded over the coaming of the door in the engine room port side casing and immediately gravitated to the starboard side of the engine room of the heeled vessel. The accumulation of water in the engine room further increased the after trim and angle of heel, and continued until the after starboard quarter of the weather deck became completely immersed (see Photograph 2).

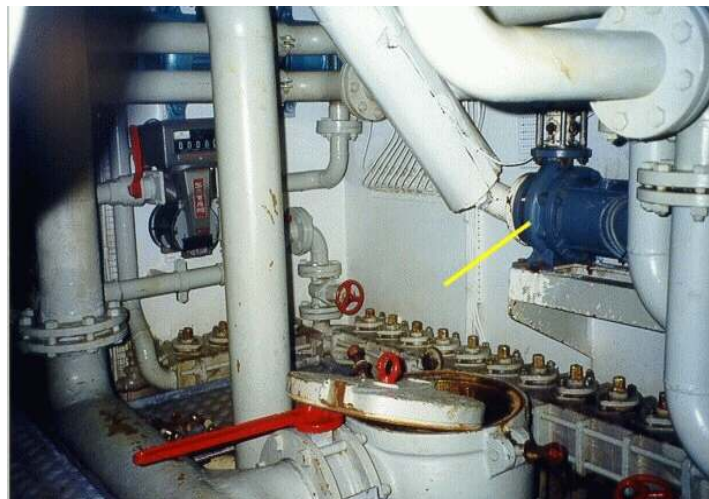
According to the two engineers who entered the engine room several times after the blackout, the only piece of equipment noted to be damaged was the standby (starboard) refrigerant pump. The pump was reported as having disintegrated or exploded. Although the pump was not in service at the time of the failure, its isolation valves were still open and when the pump failed, the entire charge of refrigerant was free to escape to atmosphere.

As the vessel sank, the starboard liquid refrigerant pump was not recovered and the cause for its failure could not be determined. No photograph is available of the pump. Photograph 3 (taken before the occurrence) shows the similar port liquid refrigerant pump.

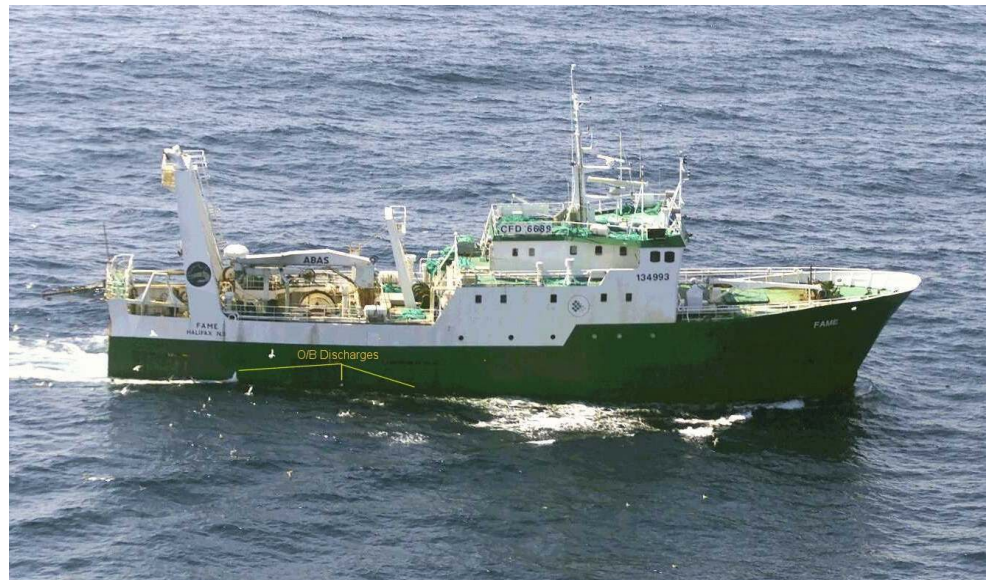
In the absence of any record of damage to the wave gate drain, offal, turbot fishing, and galley waste chutes closing devices or any other structural hull failure affecting the watertight integrity of the vessel, the most likely source of the ingress of seawater onto the factory deck was through one or more of the overboard discharge valves in the starboard side shell plating of the factory tween-deck.

After pumping power was lost, it is likely that entrained discarded fish material and other waste debris remaining in the piping system, settled and became lodged in the non-return discharge valves, causing them to malfunction. The absence of anti-syphon loops in the pump discharge piping inboard of the shipside valves, would also have contributed to the ingress of seawater through the valves onto the factory deck.

The overboard discharge valves were located above the factory deck and relatively close to the operating waterline such that, while the vessel was in calm water and heeled 3° or 4° to starboard, the valves remained above sea level. This trimmed and heeled condition was maintained for some 13 hours after the initial loss of pumping power, and would indicate that the vessel did not ship any significant amount of water throughout that period.

Photograph 4. O/B discharge valves

As the wind and seas increased, so did the rolling motion of the vessel. When heeled by the wind and rolling approximately 10° to starboard, the valves were at or just below the trimmed waterline (see Photograph 4), and became more deeply submerged as the two metre high wave crests passed along the side of the immobile vessel. The repeated immersion of the partially obstructed and ineffective discharge valves, together with the loss of electrical power to the pumps, initiated the continuous and accelerating rate of ingress of seawater through the valves onto the factory deck, which ultimately led to the loss of the vessel.

2. The loss of electrical power prevented the operation of the wastewater discharge pumps on the factory deck.
3. Seawater entered the factory deck through partially obstructed overboard discharge valves, which were not fitted with anti-syphon loops.
